Geomorphology and River Hydraulics of the Teton River Upstream of Teton Dam Teton River, Idaho

U.S. Department of the Interior
Bureau of Reclamation

May 2000

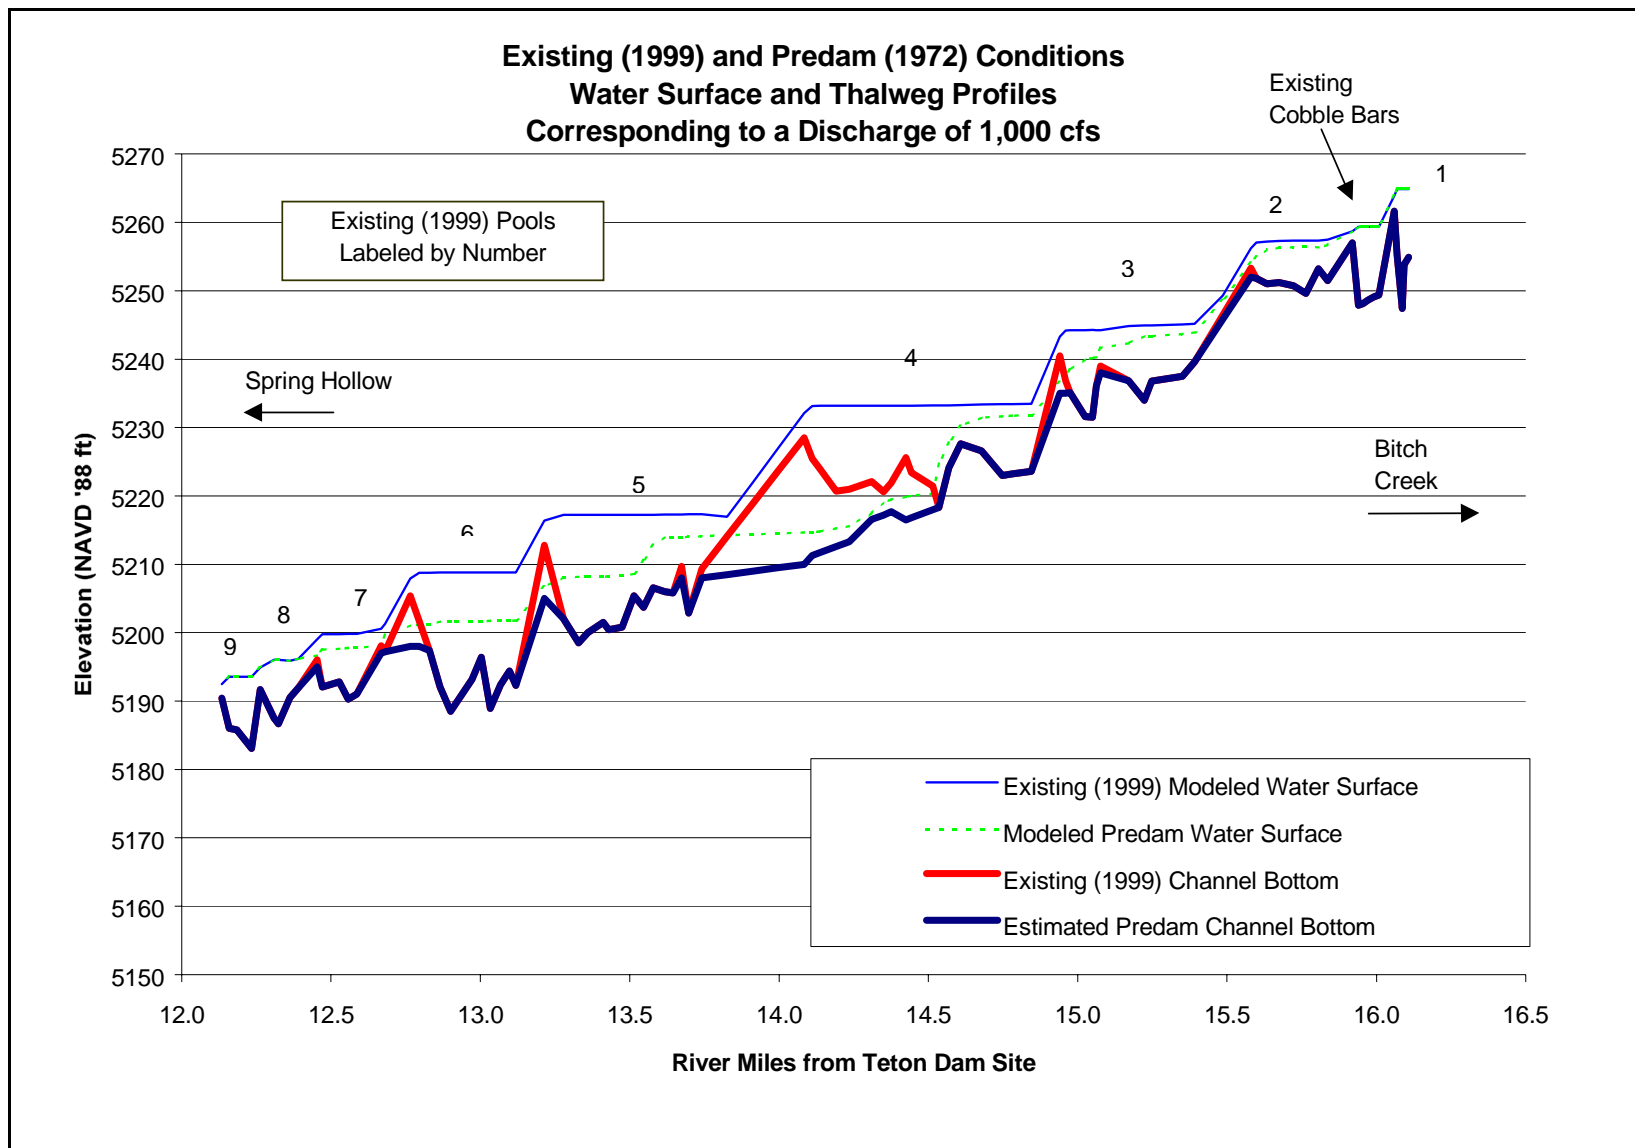
It was determined that all the rapids had been either newly created or enlarged from the 1972 conditions (refer to tables 9 and 10). The 1976 landslide debris raised the channel bottom and constricted the channel width in rapid locations. Typical channel widths in 1972 were about 200 feet, but 1976 landslides have often constricted the river to half this width at rapid and riffle locations. Based on aerial photograph analysis and field observations, it was also determined that there were four locations between Bitch Creek and Canyon Creek where the river had not changed since 1972. These locations were upstream of pool 1, near Spring Hollow, the long chute of riffles downstream from pool 23, and the bottom of rapid 27 at the end of the modeled reach. Linderman Dam was the only portion of the river that had a higher water surface elevation in 1972 than the existing water surface elevation. In 1972, Linderman Dam created a 10-foot drop in water surface and formed a 3,600-foot-long pool upstream. Linderman Dam has since been partially removed. The remainder of the dam causes a 2-foot drop in water surface but does not significantly back up water past pool 17.

Figure 6.—Comparison of existing (1999) and predam (1972) water surface and thalweg profiles (RM 12.1 to 16.1).

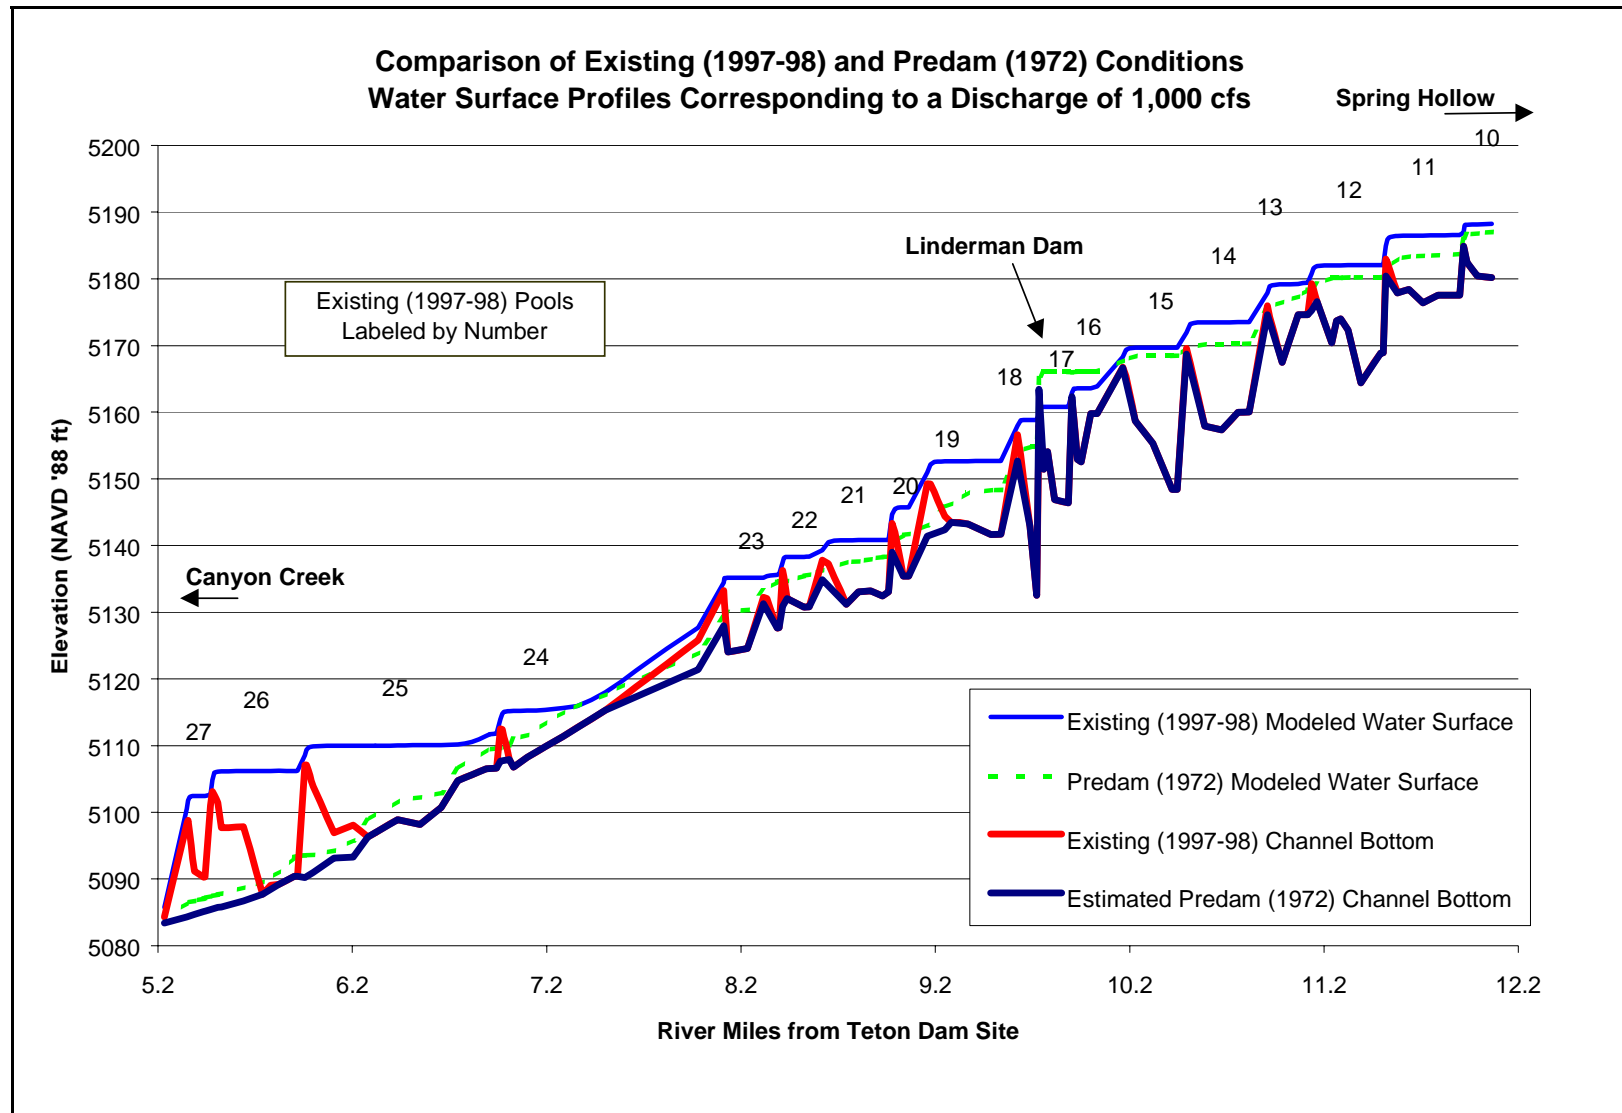
Figure 7.—Comparison of existing (1997-98) and predam (1972) water surface and thalweg profiles (RM 5 to 12.1).
